Application of acoustic scanner data in determining end wall stability

A case study from an operating coal mine in the Hunter Valley, New South Wales

R Henwood¹, S Pell²

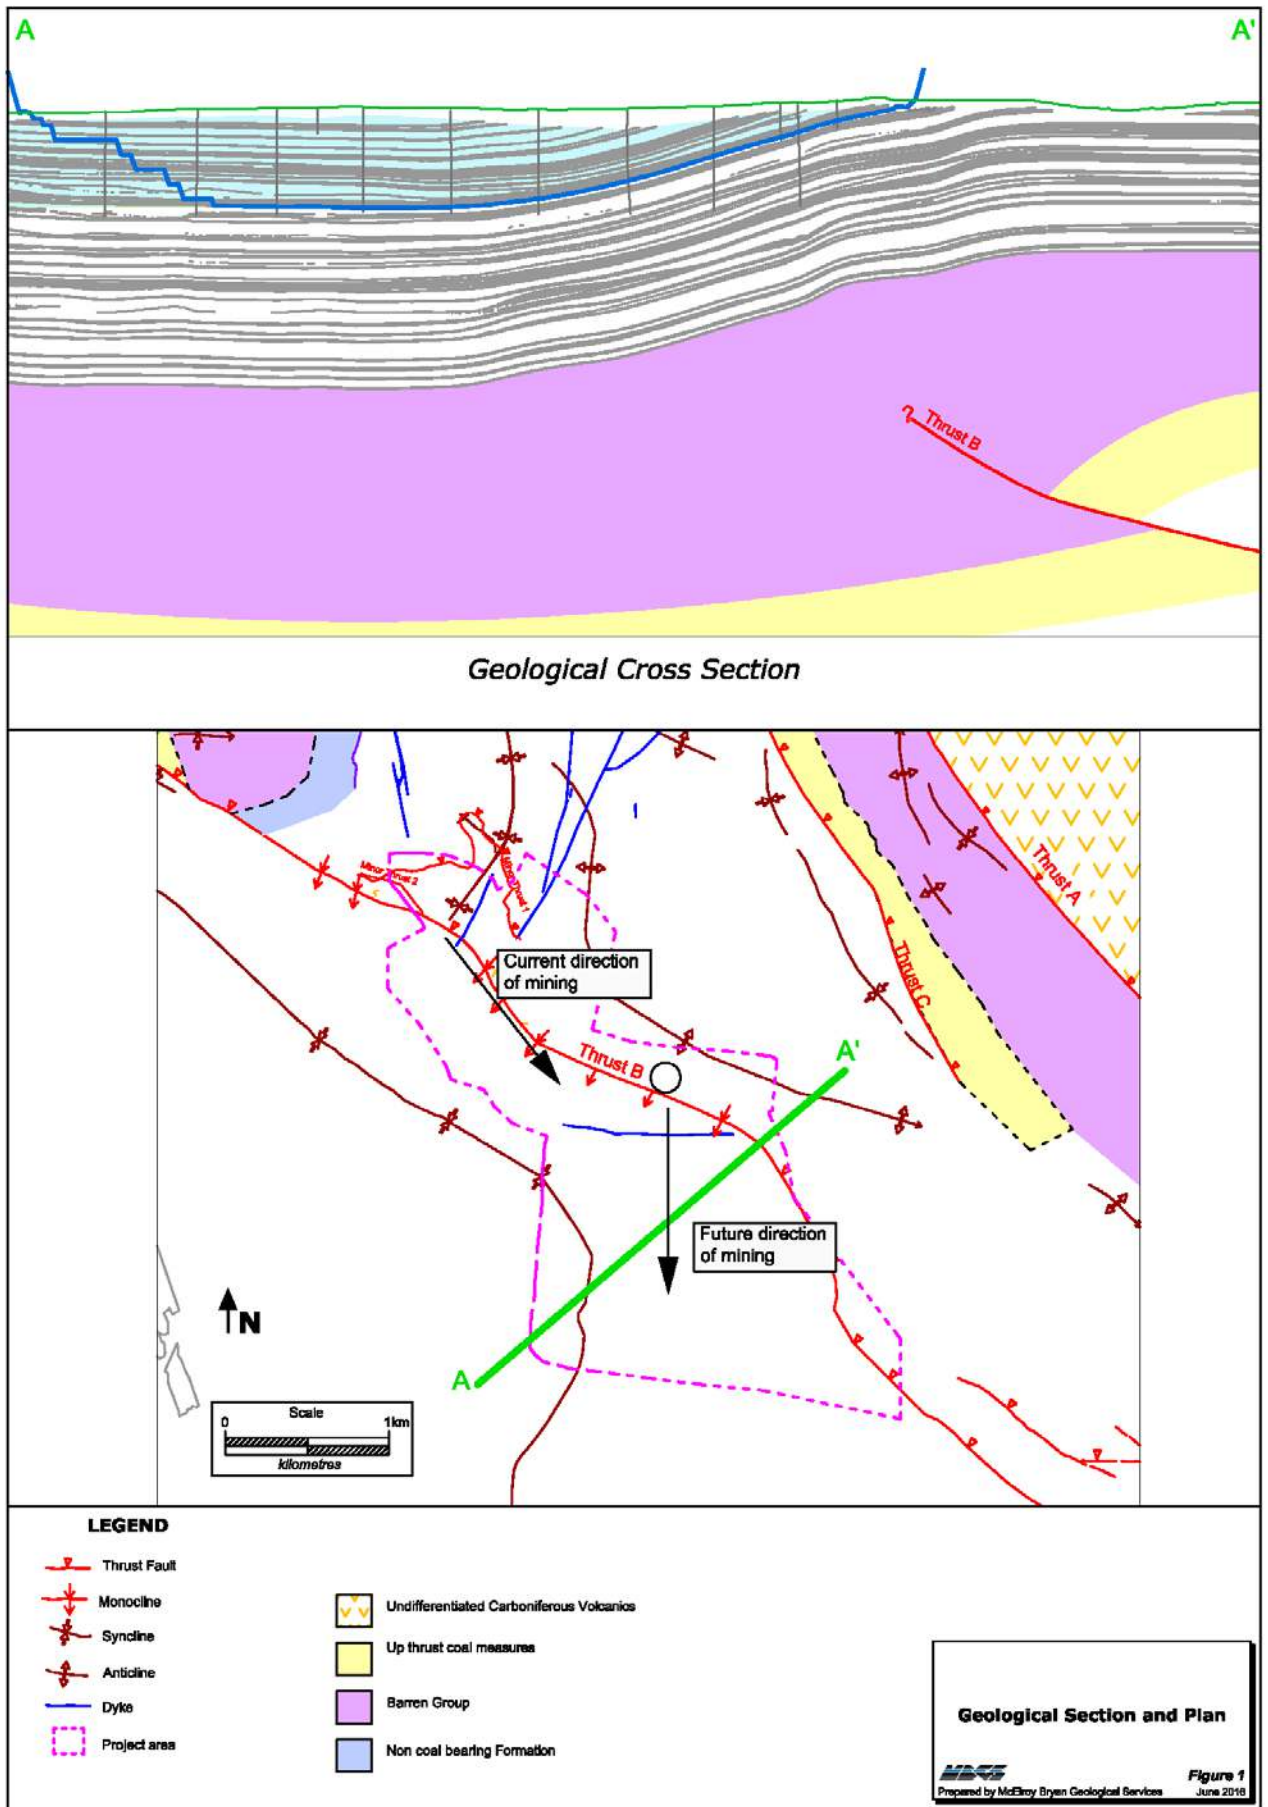
Figure 1 – Project area geology and geological section

Structural geology at the mine site is complex with multiple synclines, anticlines and thrust faults present (Figure 1). Major structural features including faults, folds and dykes traverse the area and seams have been subjected to a number of post-depositional tectonic phases with structural complexity decreasing from north to south.

Along the western edge of the current mining operation is Thrust B. This is a major northeast dipping thrust fault extending several kilometres north of the mine site. Deformation structures associated with Thrust B in the project area accommodate displacement at depth. Deformation at the surface resembles a monocline with small scale, localised thrust faults (typically <2 m displacement).

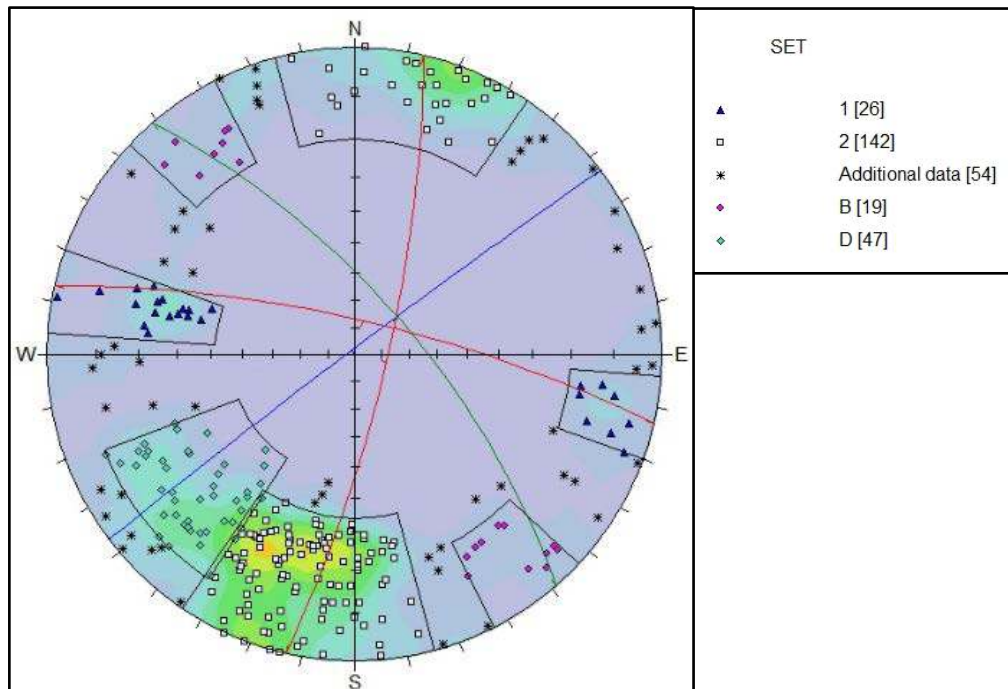
Figure 2 – Example stereonet showing the dominant joint sets in a drill hole

The acoustic scanner logs were reviewed and, where necessary, the interpretation was refined. Only joint data with high confidence was presented and all other features (such as faults and borehole breakout) were removed to reduce noise. The joint sets of interest occurred mainly in interburden strata, so jointing within coal seams was disregarded. Additional bedding, the strike of which is variable throughout the deposit, was also analysed in each hole to aid identification of the J1 and J2 joint sets and differentiation from the D joint set. Joint sets and bedding were presented as stereonet plots for the total hole (Figure 2) and in depth increments of 100 m.

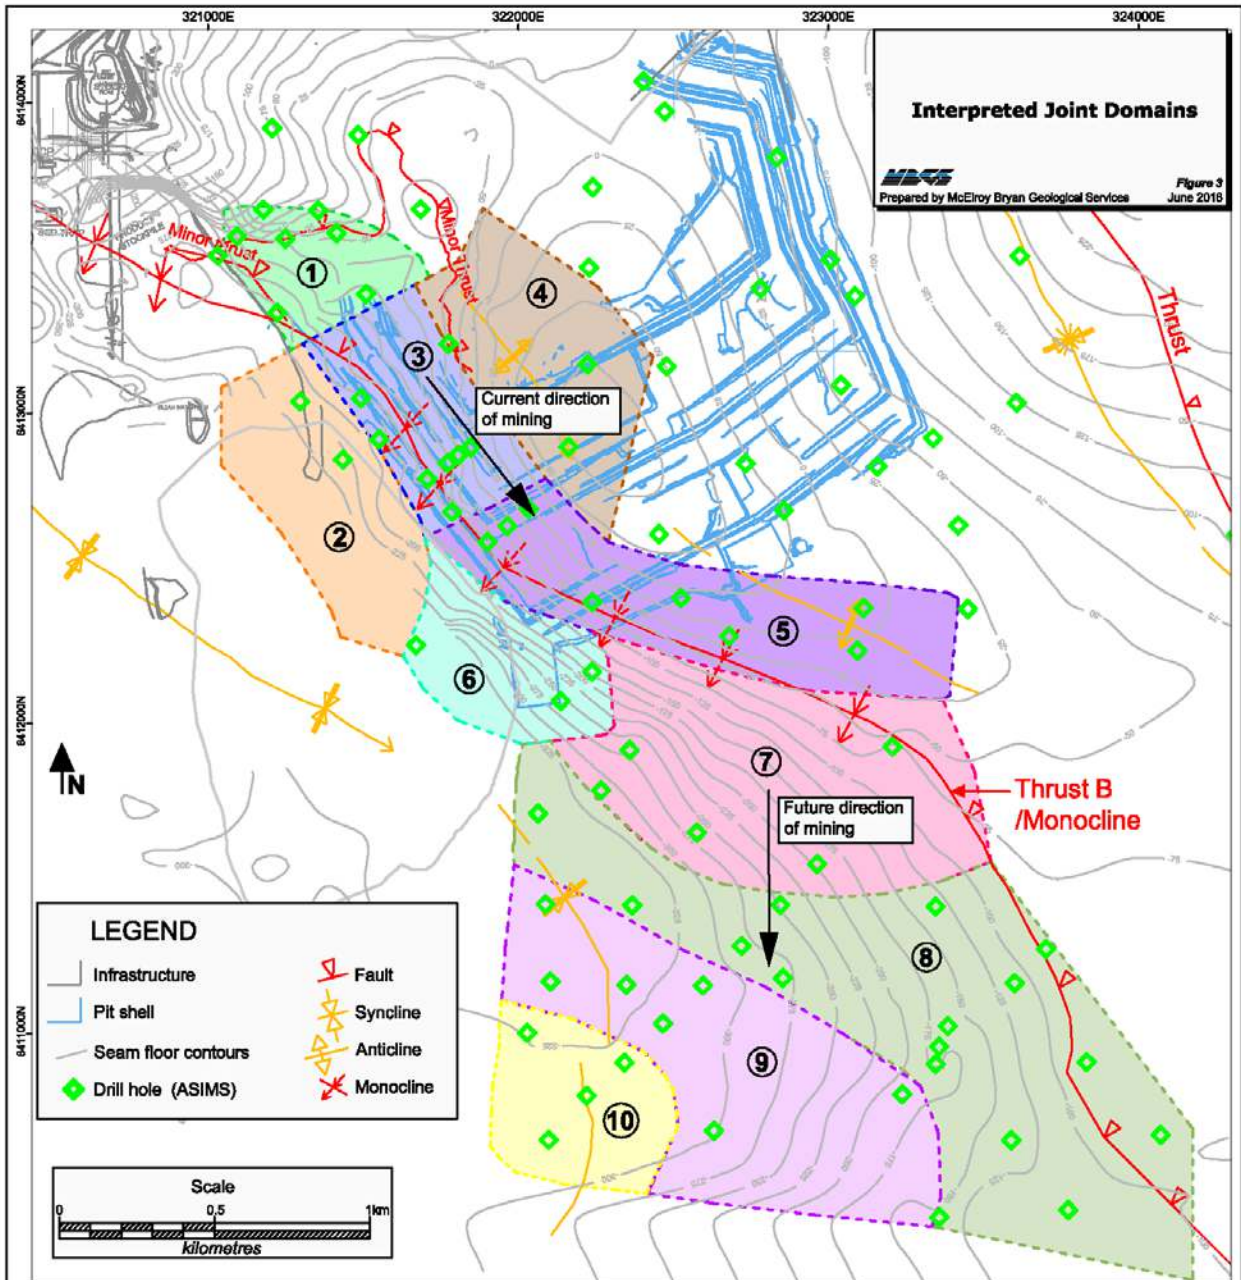
Figure 3 – Joint domains identified using acoustic scanner interpretation results

Once all drill holes had been interpreted and reviewed, the project area was divided into ten domains based on similar joint orientations and characteristics. These are shown in Figure 3. These joint domains will aid in medium to long term planning of the development of the pit to minimise geotechnical instability.

- Domain 1: Joint sets variable. No discernable joint pattern. Minor Thrusts 1 and 2 present generating variable strata dip.
- Domain 2: J2 sets present. Strata dip 10-15° to southwest.

- Domain 3: J1 and J2 joint sets present. J2 and De joint sets similar in dip direction; East: De dip angle is shallower than J2 dip angle; West: De dip angle is equal to or steeper than J2 dip angle; From west to east: De dip angle rotates towards the vertical. A and B joints becoming common. Southern end of zone J2 and De dip directions diverge by 20-40°. Strata dipping 25-35° towards southwest.

- Domain 4: J1 and J2 joint sets present. Strata dipping towards the west with variable dip.
- Domain 5: J1 and J2 joint sets present. De joints less common; where present, dip angle steeper than J2 and diverge by 40°. B joints more common in south. Rn may be developing in south. Bedding dip direction is rotating towards the south in the south. Dip is variable.

- Domain 6: J1 and J2 joint sets present. De dipping shallower than J2. De, Dw, A and B all common.
- Domain 7: J1 and J2 joint sets present. Rn becoming common in south, often with similar dip and dip direction to J2. Few occurrences of D and A joints. Strata dipping southwest.

- Domain 8: J1 and J2 present. A common near the eastern endwall. De and J2 have similar dip and dip direction in strata dipping towards 255-265 and often not separable. West-southwest dipping strata and southern portion of domain shows De, J2 and Rn as distinct sets with similar dip and varying dip direction. Strata varies from west-southwest to west.

- Domain 9: J1 and J2 joint sets present. Few other joints near western endwall. A present in centre and south of domain. De and Dw joints present, however typically not common. Strata dipping west-northwest to west.

- Domain 10: J1 and J2 joint sets present. De and B may be present. Strata dipping north to north-northwest.
